**Eurasian water-milfoil (*Myriophyllum spicatum*)
Late-summer Bed Mapping Survey
Mud Lake (WBIC: 2434800)
Sawyer County, Wisconsin**

The Callahan and Mud Lakes Protective Association,
Lake Education and Planning Services, LLC, and the
Wisconsin Department of Natural Resources (Grant ACEI35725)

Endangered Resource Services, LLC
Matthew S. Berg, Research Biologist
Saint Croix Falls, Wisconsin
August 30, 2025

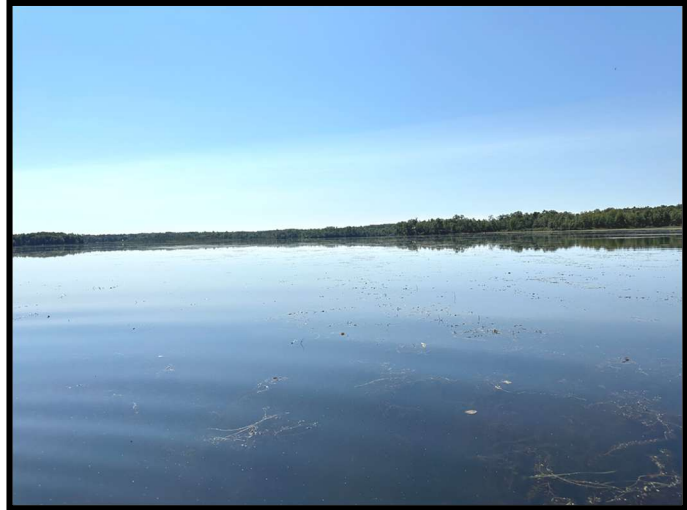
Canopied mat of Eurasian water-milfoil visible in calm conditions - 8/30/25

Beds 1-3 – Past treatments in the lake inlet have resulted in a significant decline in the Eurasian water-milfoil population in these upstream areas, and we noted Bed 2 was little more than a narrow sliver along the channel. However, Bed 1 has merged with Bed 3 and showed dramatic expansion to the south. Outside of the main navigation channel where regular boat traffic was keeping a lane open down the middle of the bed, the majority of the area's core was a dense canopied mat that represents the worst area on the lake (see report cover). Here, we noted floating fragments and prop trails were common throughout.
